Macassa Property, Ontario, Canada

Updated NI 43-101 Technical Report

Effective date of the report: 31 December 2016

Authors: Pierre Rocque, P. Eng., Doug Cater, P. Geo.
Report Addressed to Kirkland Lake Gold

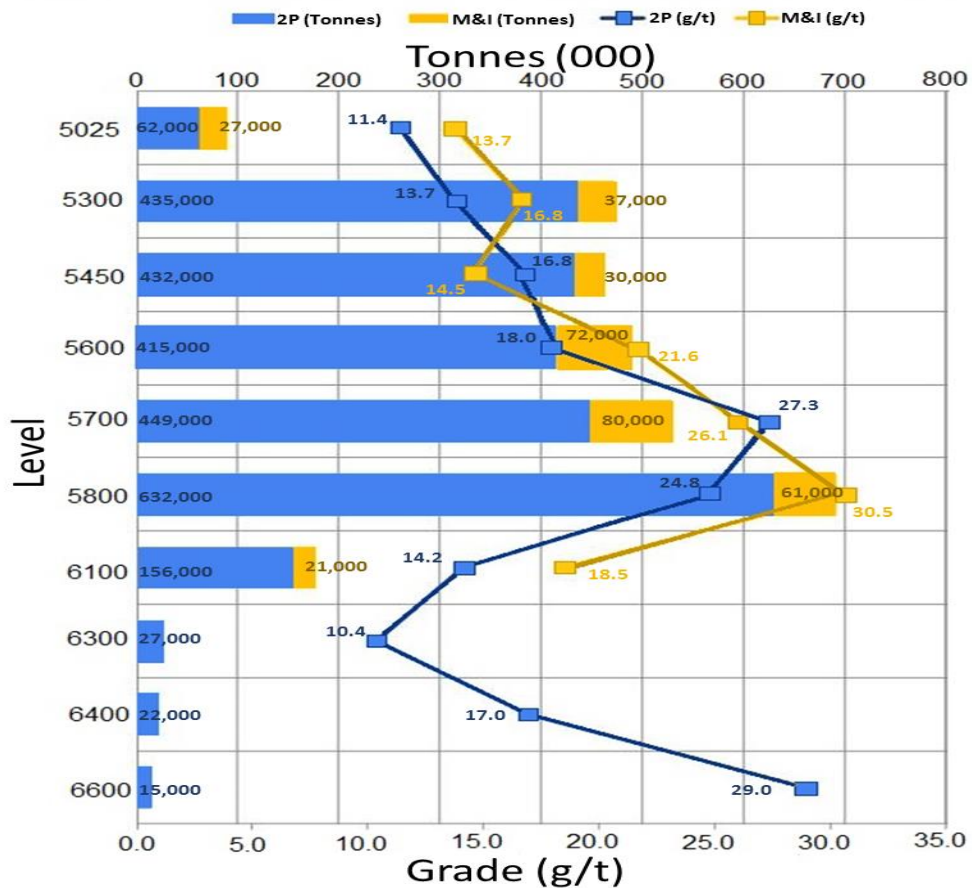
Figure 13-2 SMC Zone Mineral Reserve / Resource totals subdivided by level.

The recent Mineral Resource update continues to confirm the high-grade nature of the SMC zone at depth. Figure 13-2 depicts both the Proven and Probable Reserves and Measured and Indicated Resource tonnes sub-divided by mine level to depth. Average grades for the Reserves and Resources are shown on the right-hand side of the figure. Many of the mineralized zones that form the SMC merge with the Amalgamated Break zone below the 5800 level, however the Lower D zone which dips steeply south, has been drill tested and remains mineralized below the 7050 level.

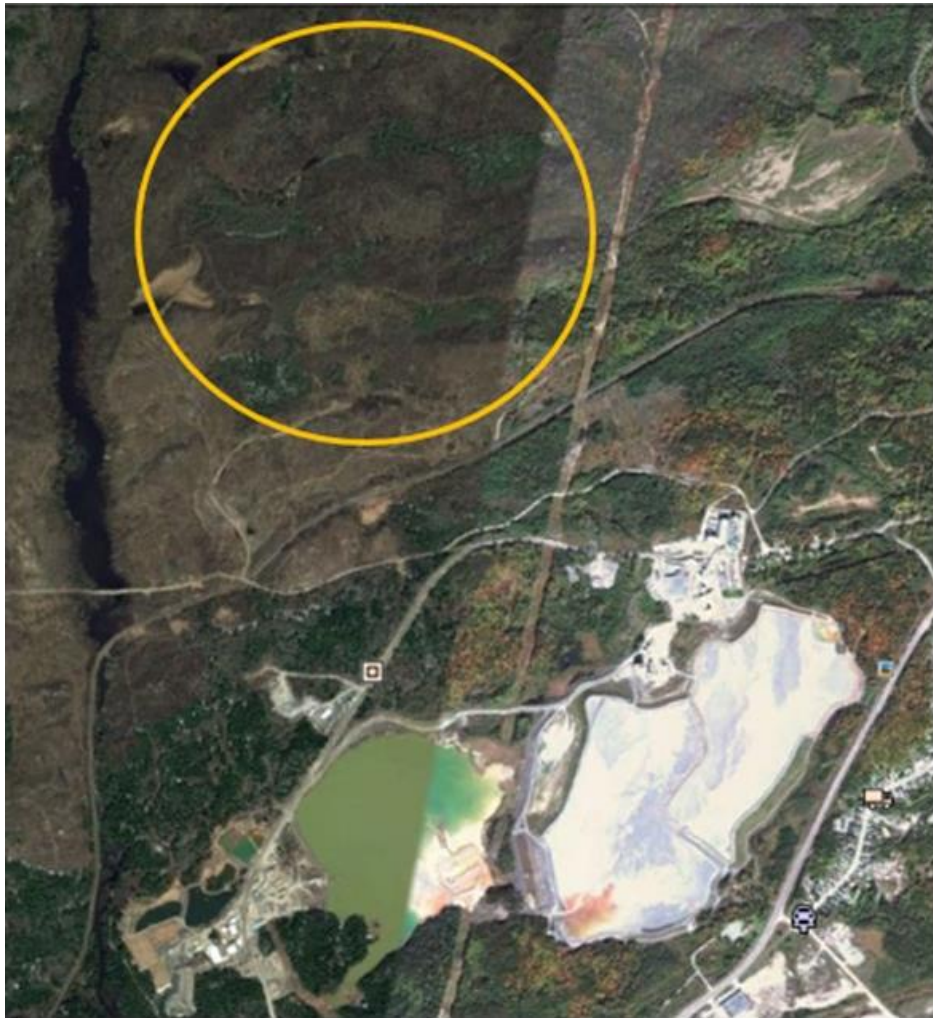
Figure 19-1: Current and proposed location of the new TSF (yellow circle).

In addition, the Macassa Complex is in the early stages of designing, permitting and constructing a new tailings storage facility (TSF). The preferred location identified for the new TSF is located to the north of the Macassa TSF (Figure 19-1). The permitting strategy and work plan associated with this program is progressing in tandem with the eventual decommissioning of the current Macassa TSF, as it will be reaching its maximum operating configuration in the upcoming years. One of the critical paths for the new TSF will be the environmental permitting aspect; KLG anticipates receiving the necessary permits required to build the new TSF.
